Navajo Abandoned Uranium Mine

Site Screen Report

Mesa IV 1/4 Mine AUM Site

Navajo AUM Northern Region

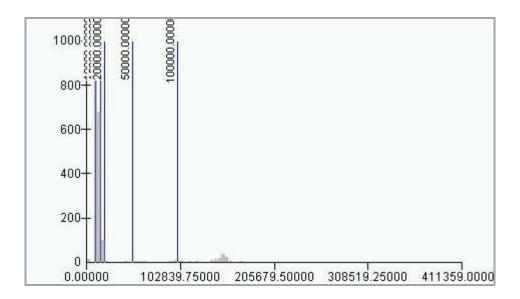
The following chart and statistics were generated by ESRI ArcGIS 9.3.1, and show the general distribution of the site gamma radiation measurements. The horizontal X axis represents the gamma radiation reading levels in cpm (lowest levels to the left). The vertical Y axis represents the frequency of each gamma radiation level.

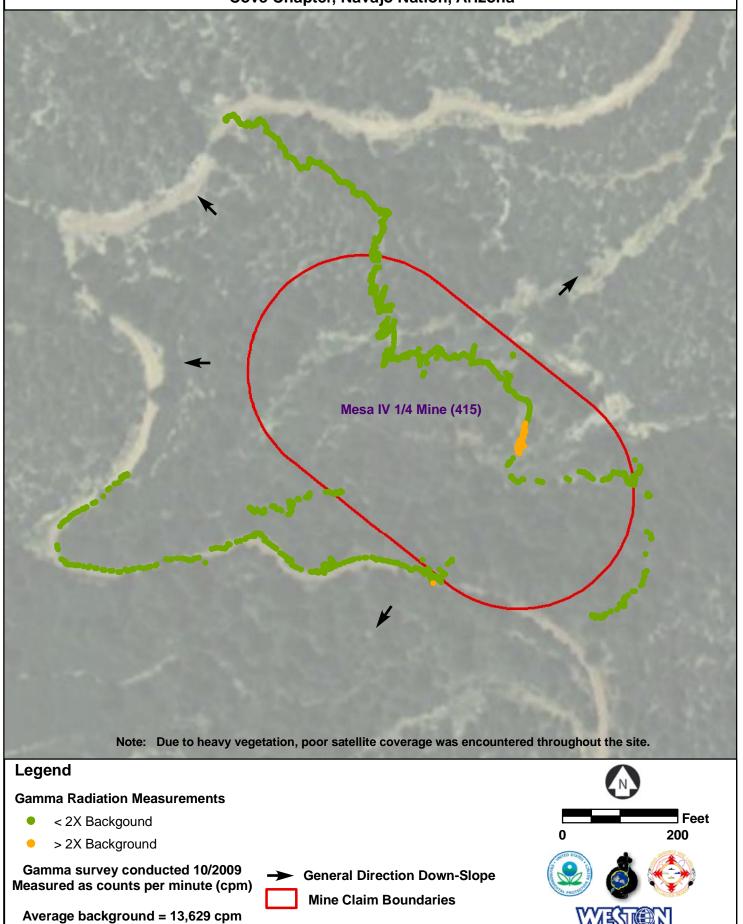
Figure 1 - Gamma Radiation Measurements, Above Two Times Background
Mesa IV 1/4 Mine (415)
Cove Chapter, Navajo Nation, Arizona

A total of 1,776 gamma radiation measurements were collected from the mine site, ranging from 8,559 cpm to 411,359 cpm. Measurements in the vicinity of the waste debris were found at levels in up to 120,000 cpm. The measurements are represented in Figures 1 and 2.
